## **Environmental Management Audit - NEMA EIA Regulation 34 Audit – July 2026**

### **Expansion of the Kuils River Cemetery**

**Erven 1338, 1368 and 6282, Kuils River,  
City of Cape Town, Western Cape**

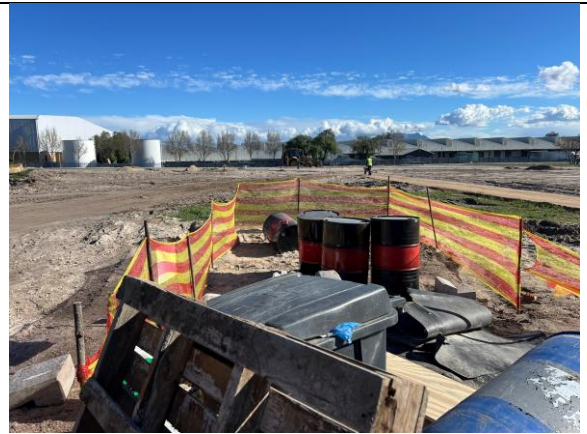
| 5. | | <p><b>Outcome: To control and eliminate fuel and oil spillages which may result in soil, surface water and groundwater contamination.</b></p> <ul style="list-style-type: none"> <li>• Pollution-control and containment measures implemented for fuels, oils and hazardous chemicals.</li> <li>• Vehicles and plant inspected for leaks and drip trays used where required.</li> <li>• Hazardous chemicals stored safely and appropriately.</li> <li>• Spill-response measures available and spills contained, cleaned up and recorded.</li> <li>• Contaminated material lawfully disposed of.</li> </ul> | <p><b>PARTIALLY COMPLIANT</b></p> | <p><b>Fuel and oil spillages were not consistently prevented through the required controls during the audit period, although no fuel- or oil-related contamination was reported.</b></p> <p>The December 2025 ECO report recorded that no spill kit was available. The January 2026 report recorded that drip trays and a spill kit had not been provided, that a clearly marked fuel-storage area was required, and that the chemical-storage area still needed to be established and equipped with containment. The February 2026 report confirmed that a chemical-storage area and spill-response kit had subsequently been provided, although fuel-dispensing and equipment-maintenance areas still required demarcation. Following appointment of the current contractor, the May 2026 ECO report recorded that drip trays, a spill kit and a clearly marked fuel-storage area were still required. The June 2026 report recorded an incomplete spill kit, insufficient drip-tray provision and the continued need for a clearly demarcated fuel-storage area.</p> <p>At the audit inspection on 1 July 2026, a spill kit was available and the generator was positioned over a drip tray. No fuel or oil leakage, staining or resulting contamination was observed. Liquid tack-coat drums were, however, stored without secondary containment.</p> <p><b>Recommendation:</b></p> <p>c) Place tack drums within suitable secondary containment.</p> |

**PHOTO 8: Tack drums in a designated area but no soil protection and not in a bunded area**

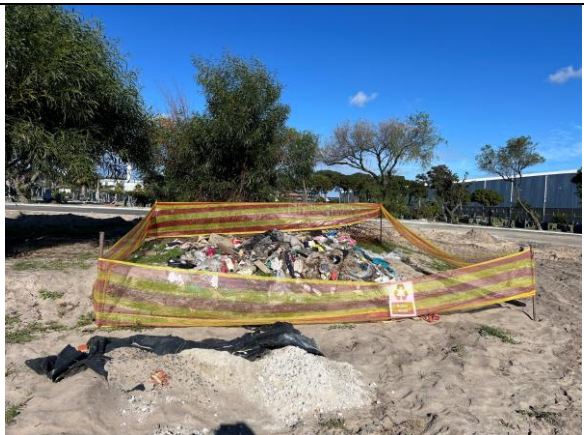
- Historical recovered waste and inherited rubble remained awaiting removal but were contained and did not present an evident immediate pollution risk.

**PHOTO 9: Waste collected to clean the site (from informal settlement) stockpiled and awaiting disposal**

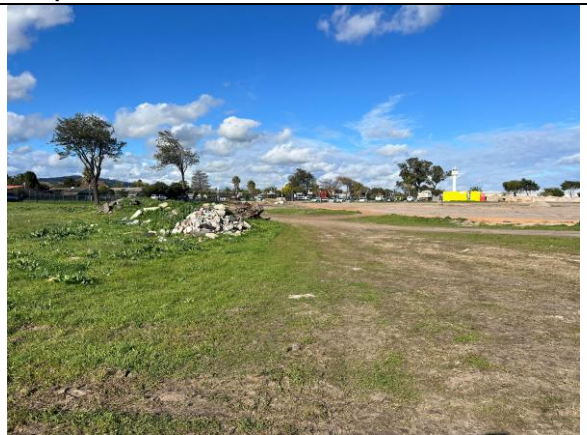
**PHOTO 10: Legacy rubble stockpiles from previous contractor awaiting disposal**

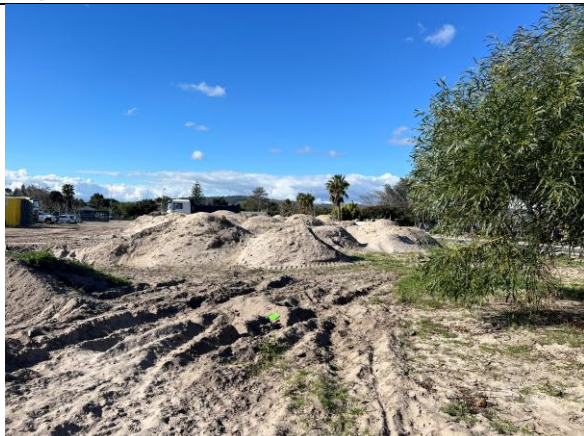
| 9. | 4.3 Dust, noise and fumes impacts | <p><b>Outcome: Prevent or minimise wind erosion and dust impacts.</b></p> <ul style="list-style-type: none"> <li>• Dust-causing activities avoided under high-wind conditions where practicable.</li> <li>• Exposed soil and stockpiles stabilised, covered or otherwise controlled where dust generation is apparent.</li> <li>• Dust suppression implemented where required.</li> <li>• Vehicles transporting sand and spoil covered with tarpaulins.</li> <li>• Dust complaints recorded.</li> <li>• Dustfall monitoring undertaken where more than one dust complaint is registered.</li> <li>• Mitigation amended where permissible dustfall standards are exceeded.</li> </ul> | PARTIALLY COMPLIANT | <p><b>Wind erosion and dust impacts were effectively minimised.</b></p> <p>Wind erosion and dust impacts were not consistently prevented during the audit period. The November and December 2025 ECO reports repeatedly required stockpile heights to be reduced and stockpiles to be covered, stabilised or wetted to limit windblown dust. In December 2025, some stockpiles remained above the recommended height and were dry and susceptible to wind dispersion, although water spraying was being undertaken.</p> <p>At the audit inspection on 1 July 2026, no dust nuisance was evident, the active work areas and stockpiles were stable, and a water truck was available for dust suppression if required. No dust complaints were recorded, and the dust fall monitoring requirement had not been triggered.</p> <p><b>Recommendation:</b></p> <p>f) Maintain stockpiles at manageable heights and cover, stabilise or wet them where there is a risk of wind erosion or dust generation.</p> |

**PHOTO 11: Sand stockpiles on site could give rise to dust generation**

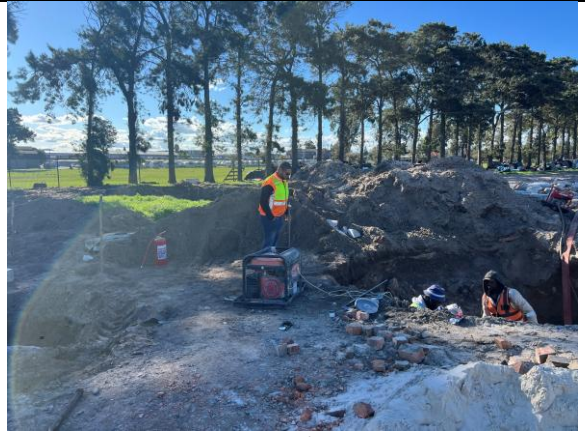
**PHOTO 16: Good use of drip trays under generator and pump**

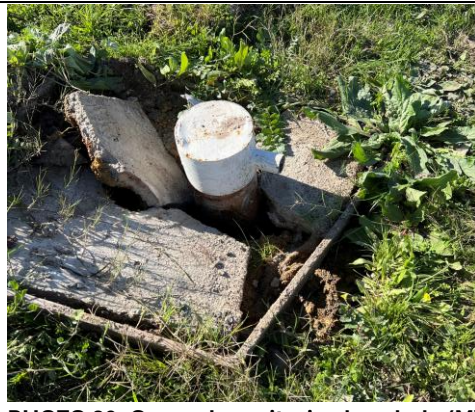
- One groundwater-monitoring well had a damaged concrete surround at the audit inspection; photographic evidence subsequently provided by the ECO confirmed that this was repaired on 15 July 2026. The prescribed groundwater-monitoring programme had not yet commenced.

PHOTO 20: Capped monitoring borehole (MW1) but the concrete cover is damaged and requires repair

h. Repair the damaged concrete surround at the upstream monitoring well. **Post-audit status: Closed out.** Photographic evidence provided by the ECO confirms that the repair was completed on 15 July 2026.

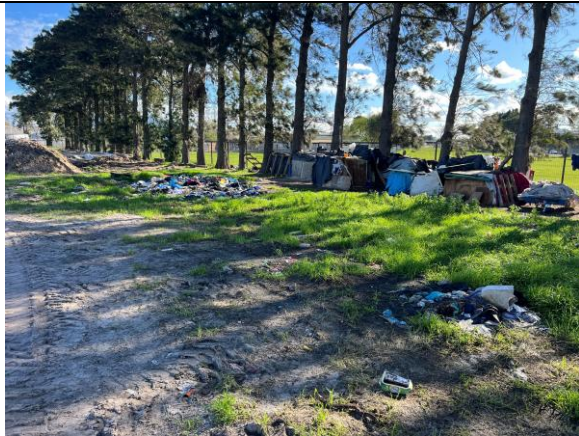
PHOTO 21: Informal settlement on site producing refuse/litter

**Note** that MW2 has been reported as installed but could not be located during the audit inspection; we suspect it may be under or between the informal settlement

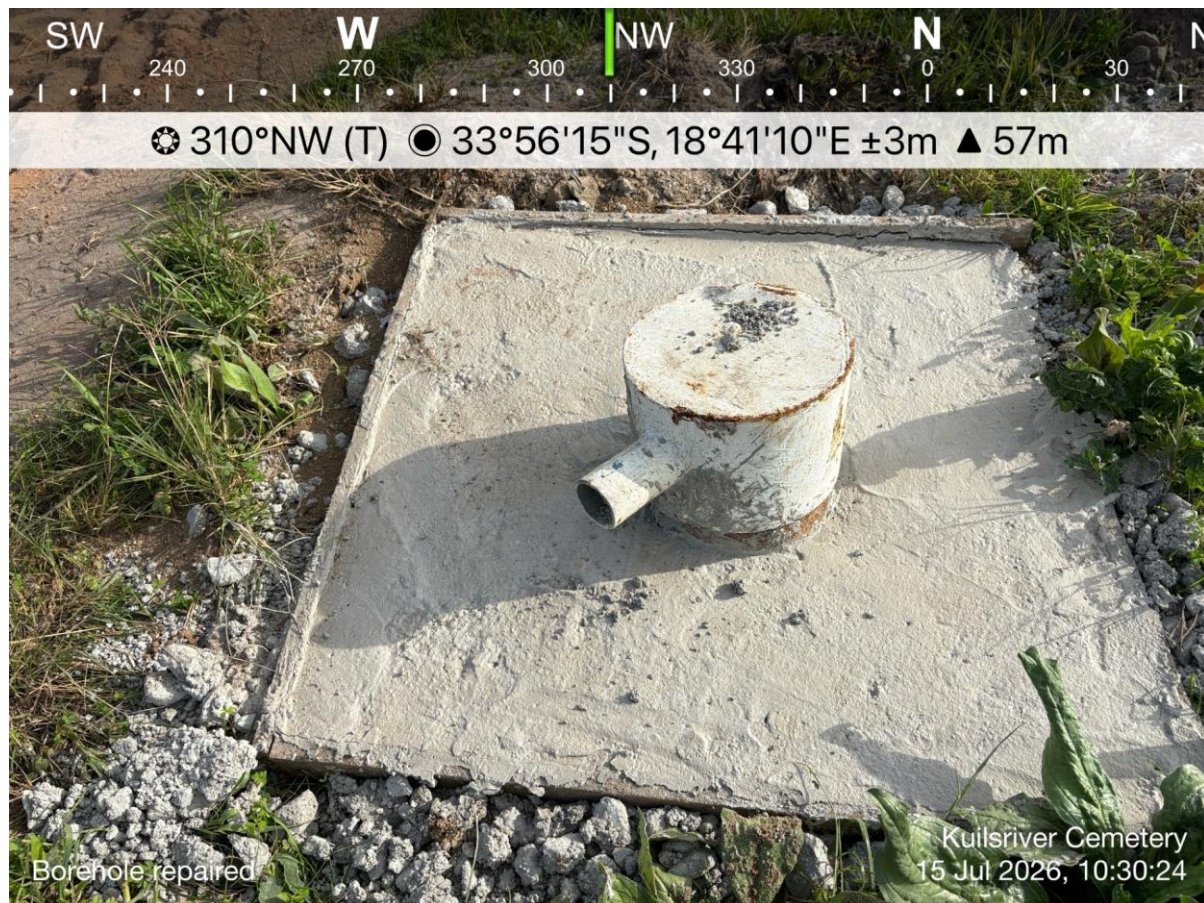
The following photograph was supplied by the ECO following the audit inspection to demonstrate repair of the concrete surround to MW1:
