**RE: TREE ASSESSMENT FOR EUCALYPTUS FOREST STIKLAND SOUTH NOVEMBER 2024**

Viridian Consulting Landscape Architects were requested to assess the existing Eucalyptus forest located on Stikland South, east of De La Haye road in terms of the possible development opportunities and constraints should development occur within this forest area. Viridian Consulting Landscape Architects conducted a site visit on Wednesday 13 November 2024 to inspect the forest and condition of the trees. René Maria Brett, Landscape Architect and Daan Loock, Consulting Arborist conducted the site visit mid-morning in light wind conditions.

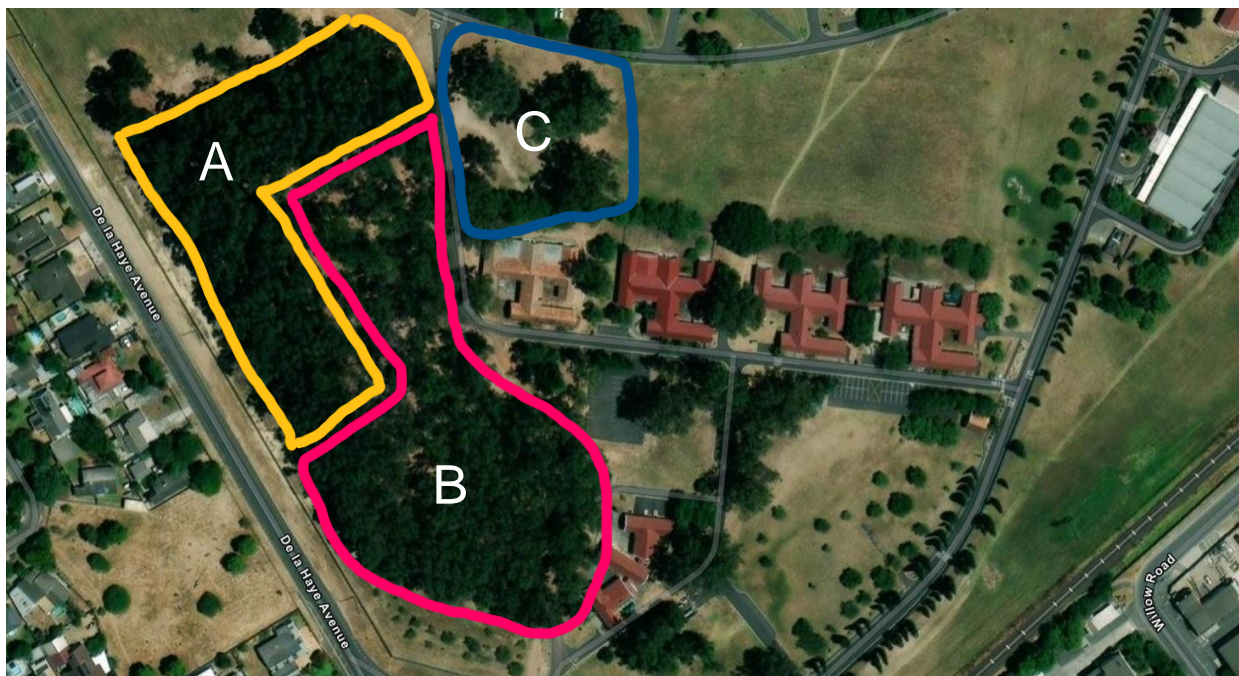
Figure 1: Reference diagram identifying areas within the Eucalyptus Forest

- The Eucalyptus forest is generally in good health and portions are in excellent health.
- A portion (indicated as A on the diagram overlay of the aerial photo below Figure 1) of the forest was clearly a managed woodlot but it is evident that no recent harvesting of timber has taken place or active management of the wood lot.

- Many trees were removed along De La Haye road at some point probably due to Eskom servitude. Stumps are still visible in the ground.
- Tree spacings (and trunk and branch structures) on the eastern and southern portion are more natural and a ground cover layer is present (indicated as B on the diagram overlay of the aerial photo below, Figure 1) Refer to Figures

A: Densely spaced (historically) managed woodlot contains Eucalyptus

B: *Eucalyptus gomphocephala* forest (wider, more natural spacing of trees with ground cover layer)

C: Free-standing individual Eucalyptus specimens of very significant age and stature

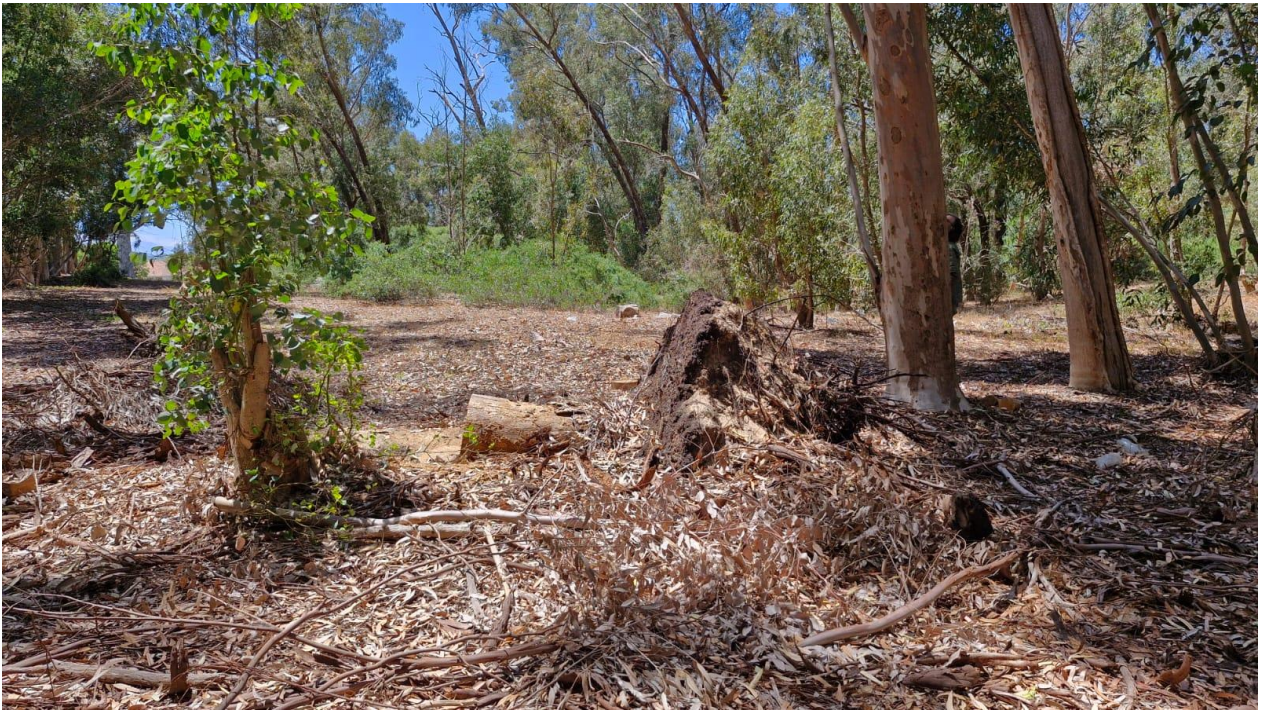
- Where a clearing was made in the middle of the forest other trees have blown over / been uprooted, indicating the sensitivity of this forest to partial clearing and exposure to higher wind speeds for trees that have matured within the protection of the forest surroundings. Refer to Figure 2.

Figure 2: A clearing in the forest where further trees are blowing over and being uprooted. The clearing increases the wind velocity within the forest and this leaves trees on the edge of the clearing vulnerable to blowing over.

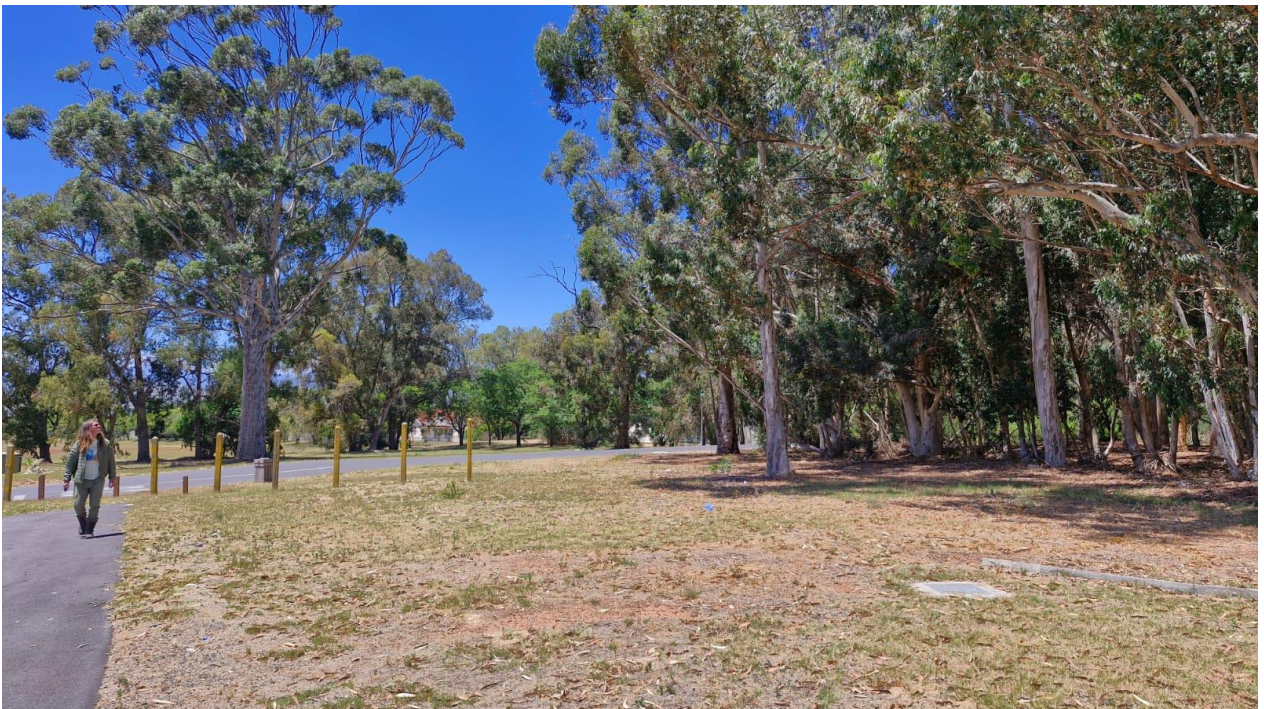
Figure 3: Eastern edge of the forest with significant free-standing specimens on the leeward side of the forest that will be impacted by increased wind velocities if the forest is removed.

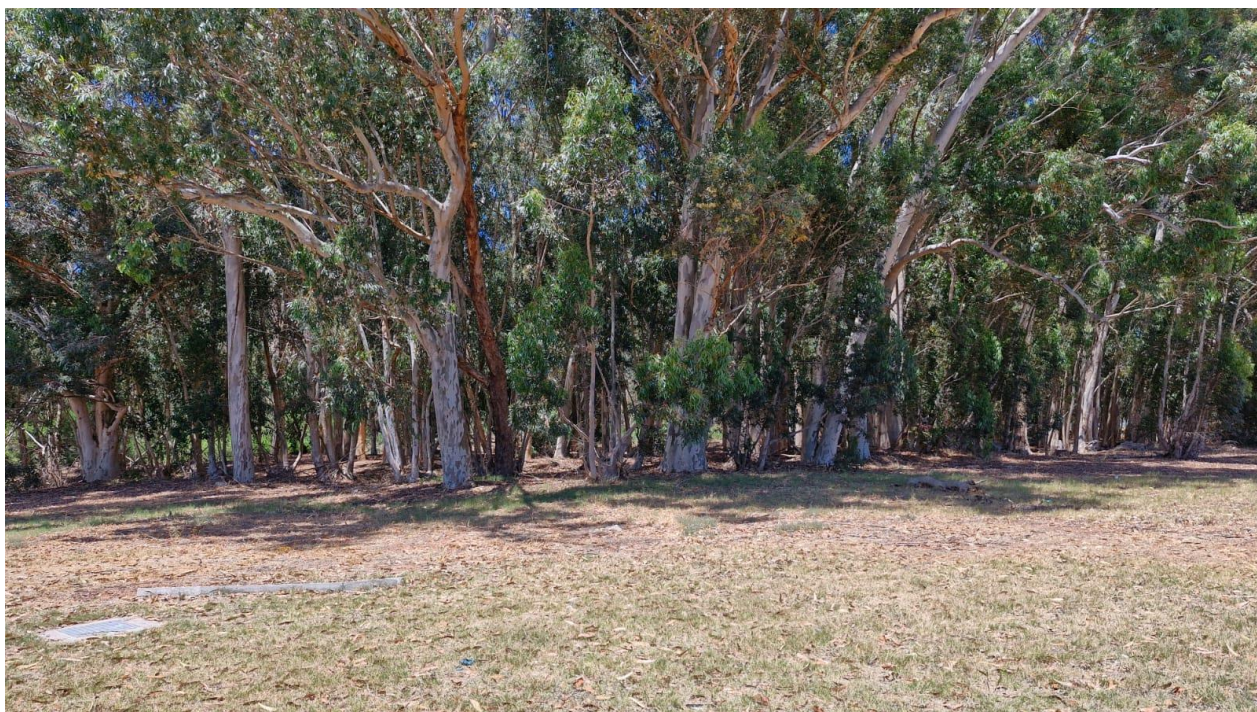
Figure 4: Northern edge of forest showing dense spacing of planted woodlot.

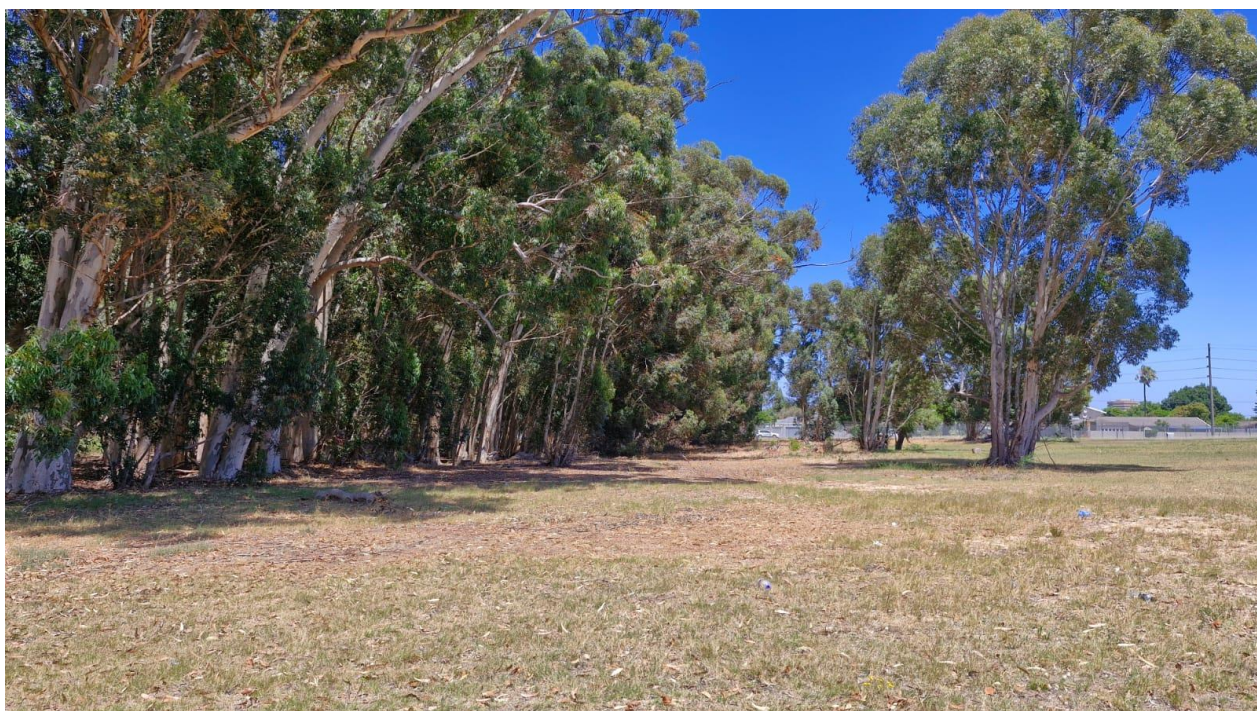
Figure 5: Northern edge of forest (densely planted woodlot section). Trees show significant lean due to dense spacing. It will require a minimum development/management setback of 15m from the canopy dripine.

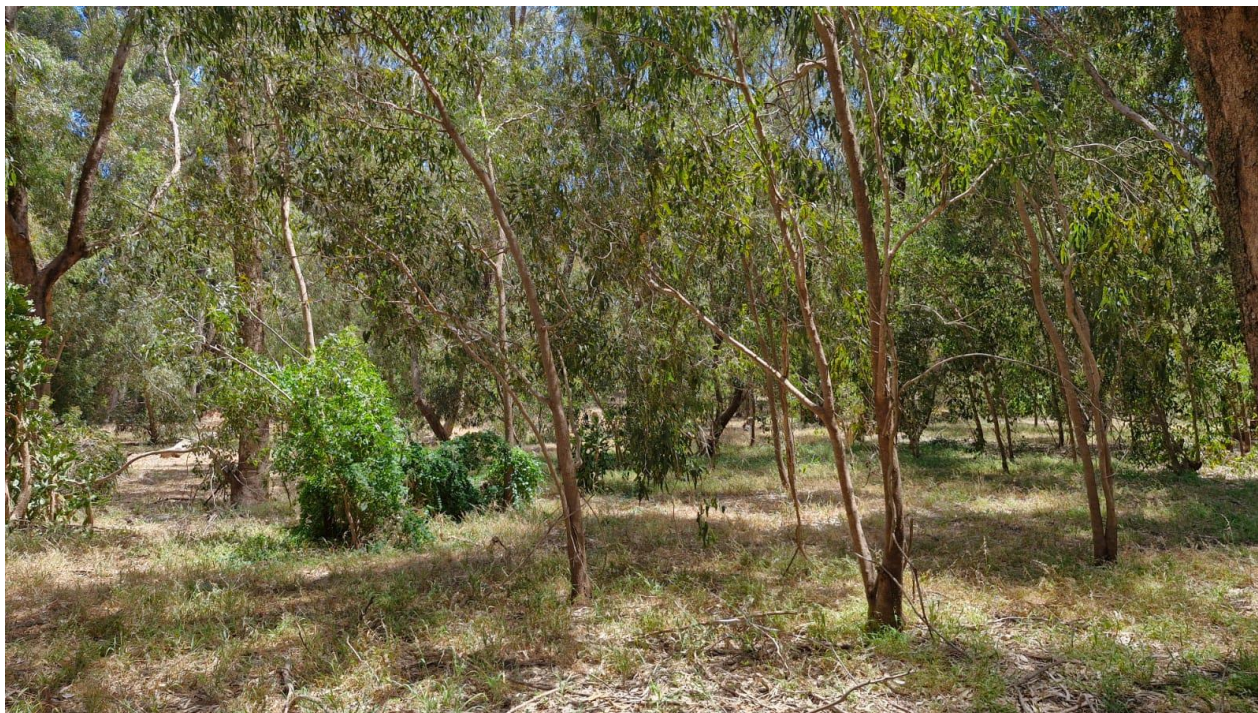
Figure 6: Southern portion of the forest with a more natural spacing of *Eucalyptus gomphocephala* / hybrids.

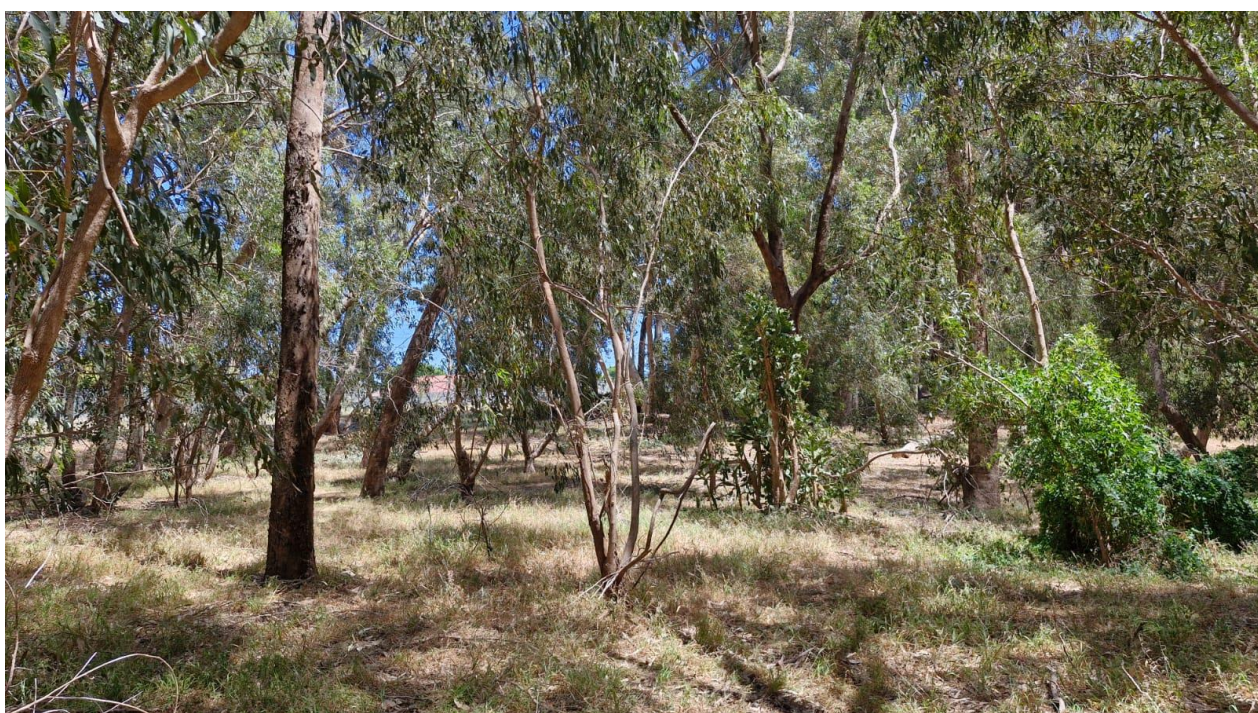
Figure 7: Another view of the southern portion of the forest showing wider spacing and groundcover layer.

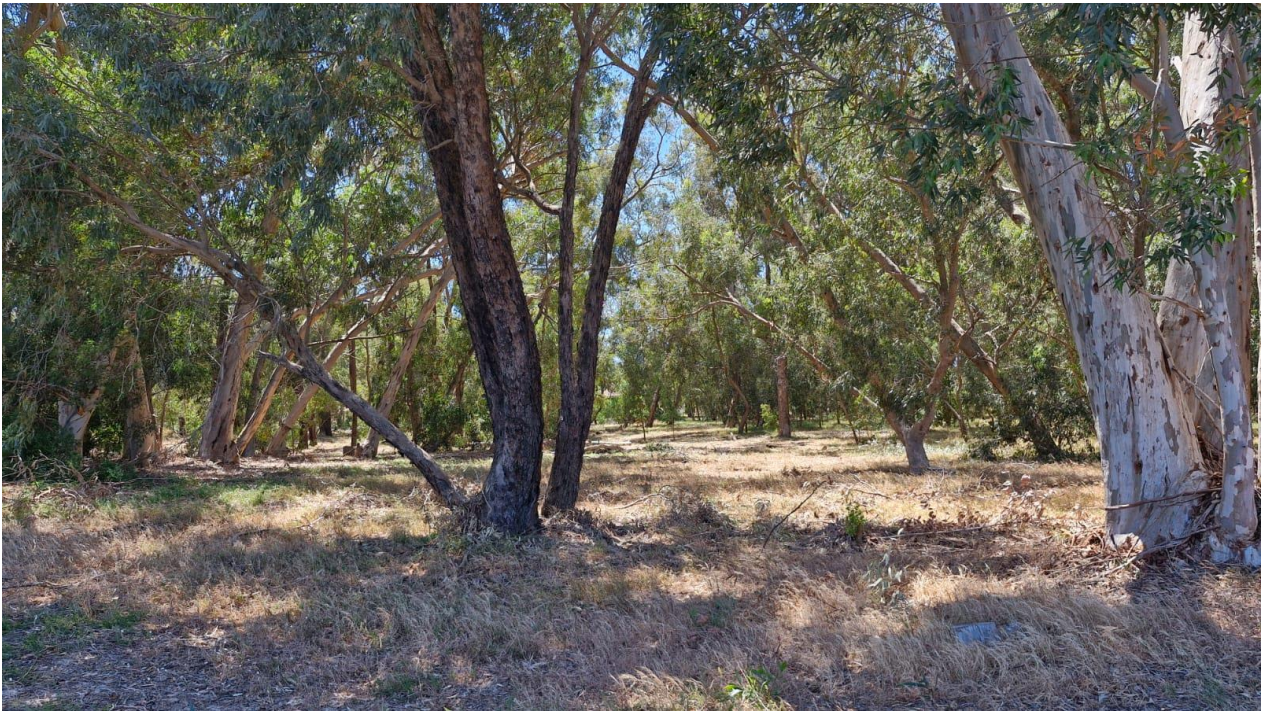
Figure 8: Mature specimens in the southern portion of the forest.

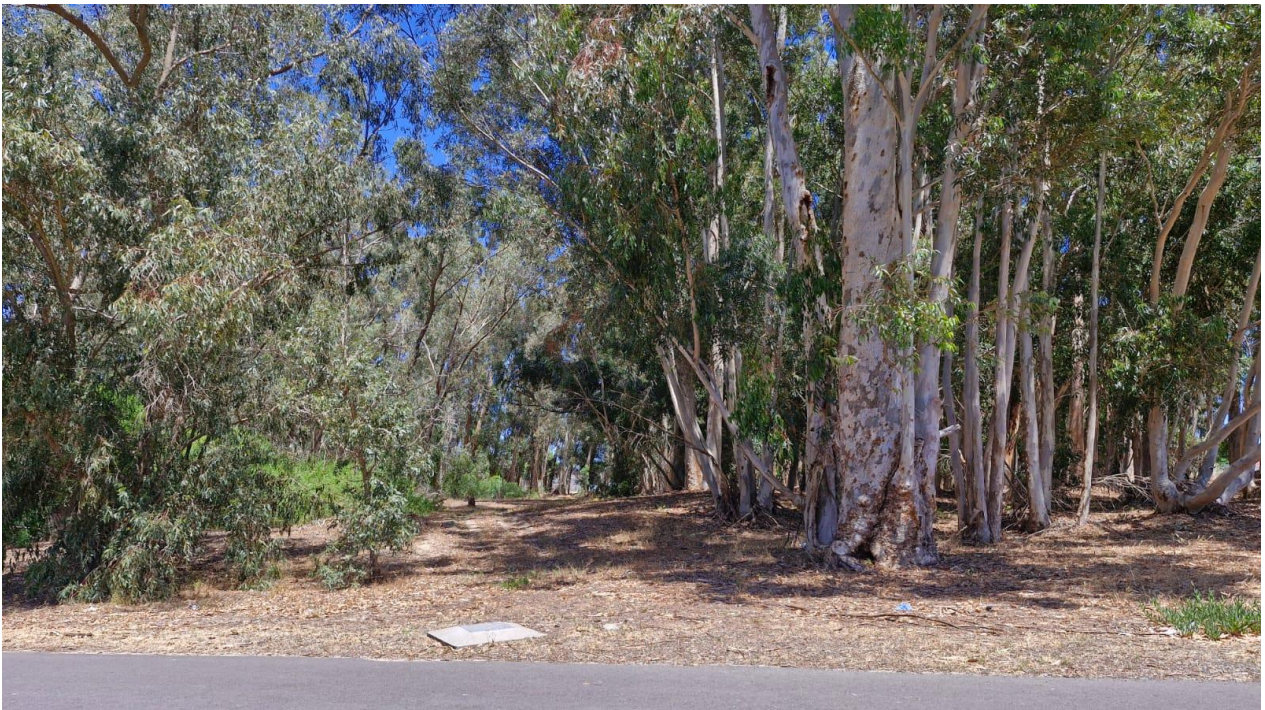
Figure 9: View into the management track on the southern side of the dense northern woodlot that would form part of the management and development setback (minimum 15m from the canopy dripline).

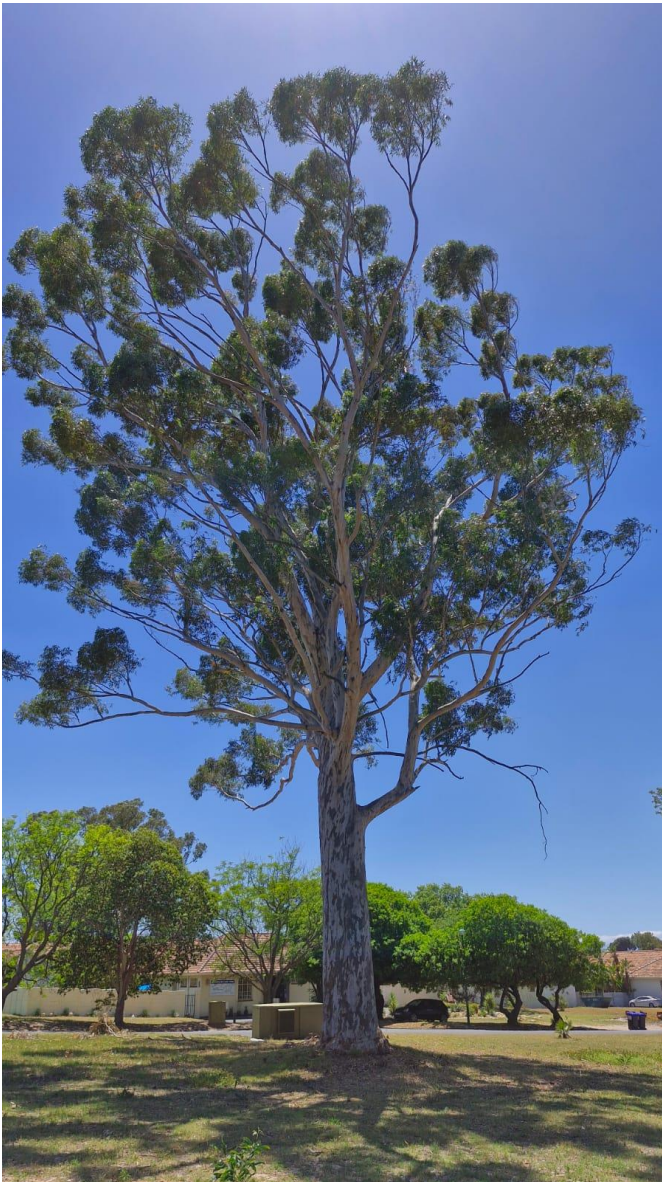
Figure 10: Free-standing Eucalyptus specimen located leeward of the forest. Original trunk formation. No coppiced regrowth. Magnificent specimen. Strongly recommended to be retained within the development footprint with development setbacks. Must be retained in combination with the woodlot portion of the forest for continued wind protection. Minimum development setback = canopy dripline plus 10m.

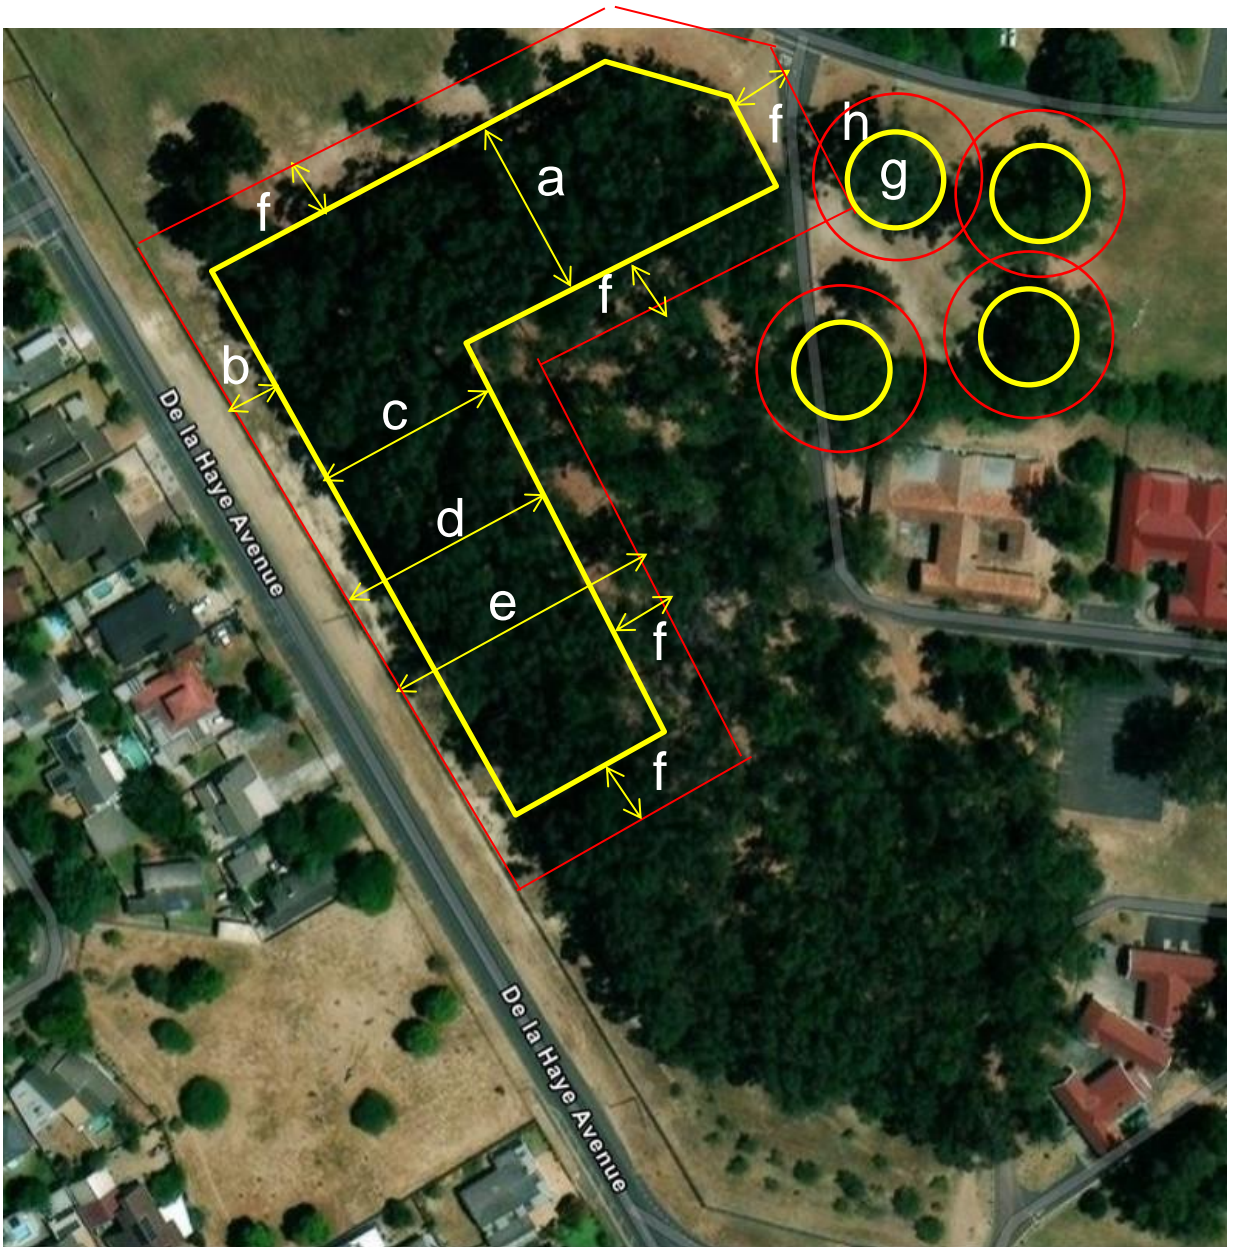
Figure 11: Recommended dimensions for the Eucalyptus forest and trees to be retained and development and management setback lines

- a = 45m
- b = 20m
- c = 45m
- d = 60m
- e = 70m
- f = 15m
- g = Canopy dripline
- h = 10m

- Trees within the densely spaced wood lot portion of the forest show unnatural lean that require ongoing monitoring and management programme.
- Please refer to the Figure 11 below for recommendations on trees to be retained and required management and development setbacks.
