RE: Validity, relevance and revision of aquatic specialist recommendations for continuation of construction of the Gwaing River Bridge.

2. Site Visit

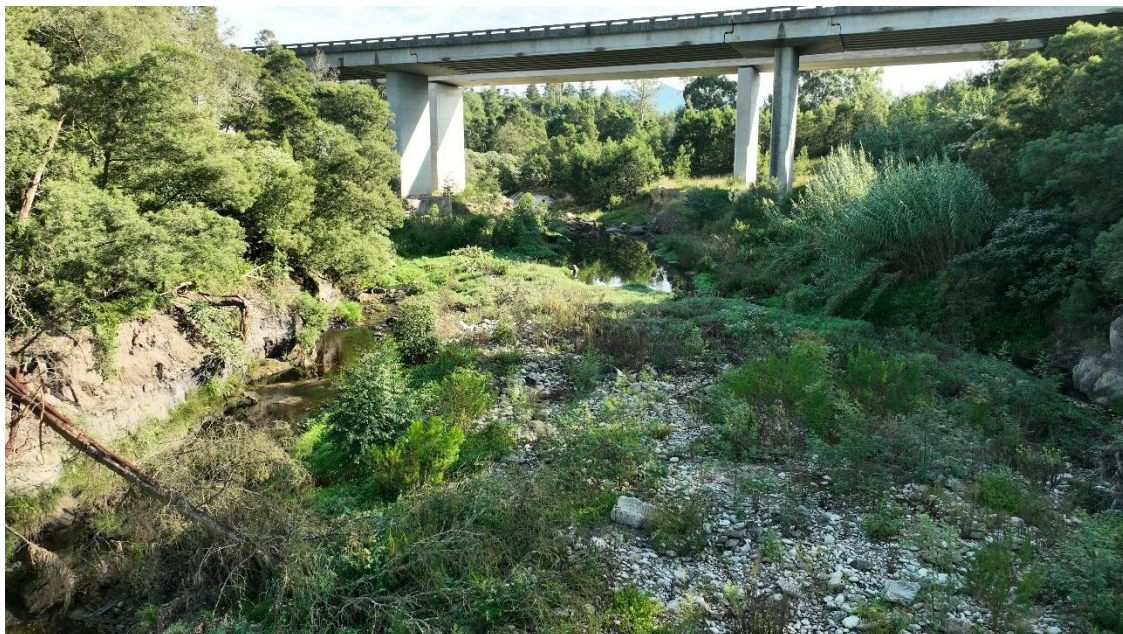
- Extensive construction-related debris remains around the river which includes: broken pipes, concrete blocks, fill material (stone-chips and G5), metal rebar, sandbags, large sacks full of sand and rocks.

- Serious channel incision has occurred following flood events, but especially following the 1:150 rainfall event experienced in November 2021. Large areas of bedrock are exposed, and eroded banks are around 3m high.

Figure 1. Photo of the Gwing River bed looking upstream towards the N2 bridge.

- Rehabilitation efforts must focus on two key aspects, being a) stabilisation of eroding banks, preferably through building up the river bed towards its original level (or at least a bit closer towards that); and b) control of alien vegetation through removal and active planting with indigenous plants. The latter will require ongoing maintenance until indigenous vegetation has established at least 80% cover in the construction footprint area.
