STIKLAND SOUTH PRECINCT LANDSCAPE FRAMEWORK

August 2025

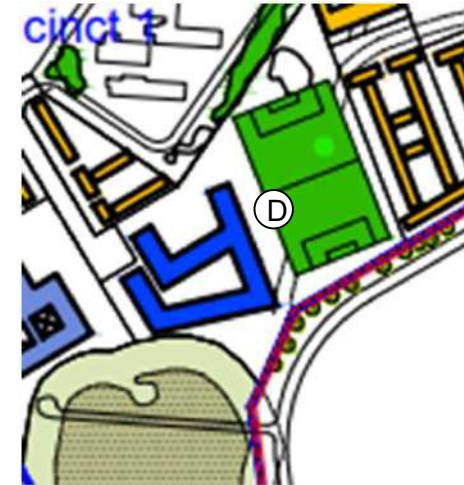
4.5 Typology E : Green Belt with Cycle / Jogging Track

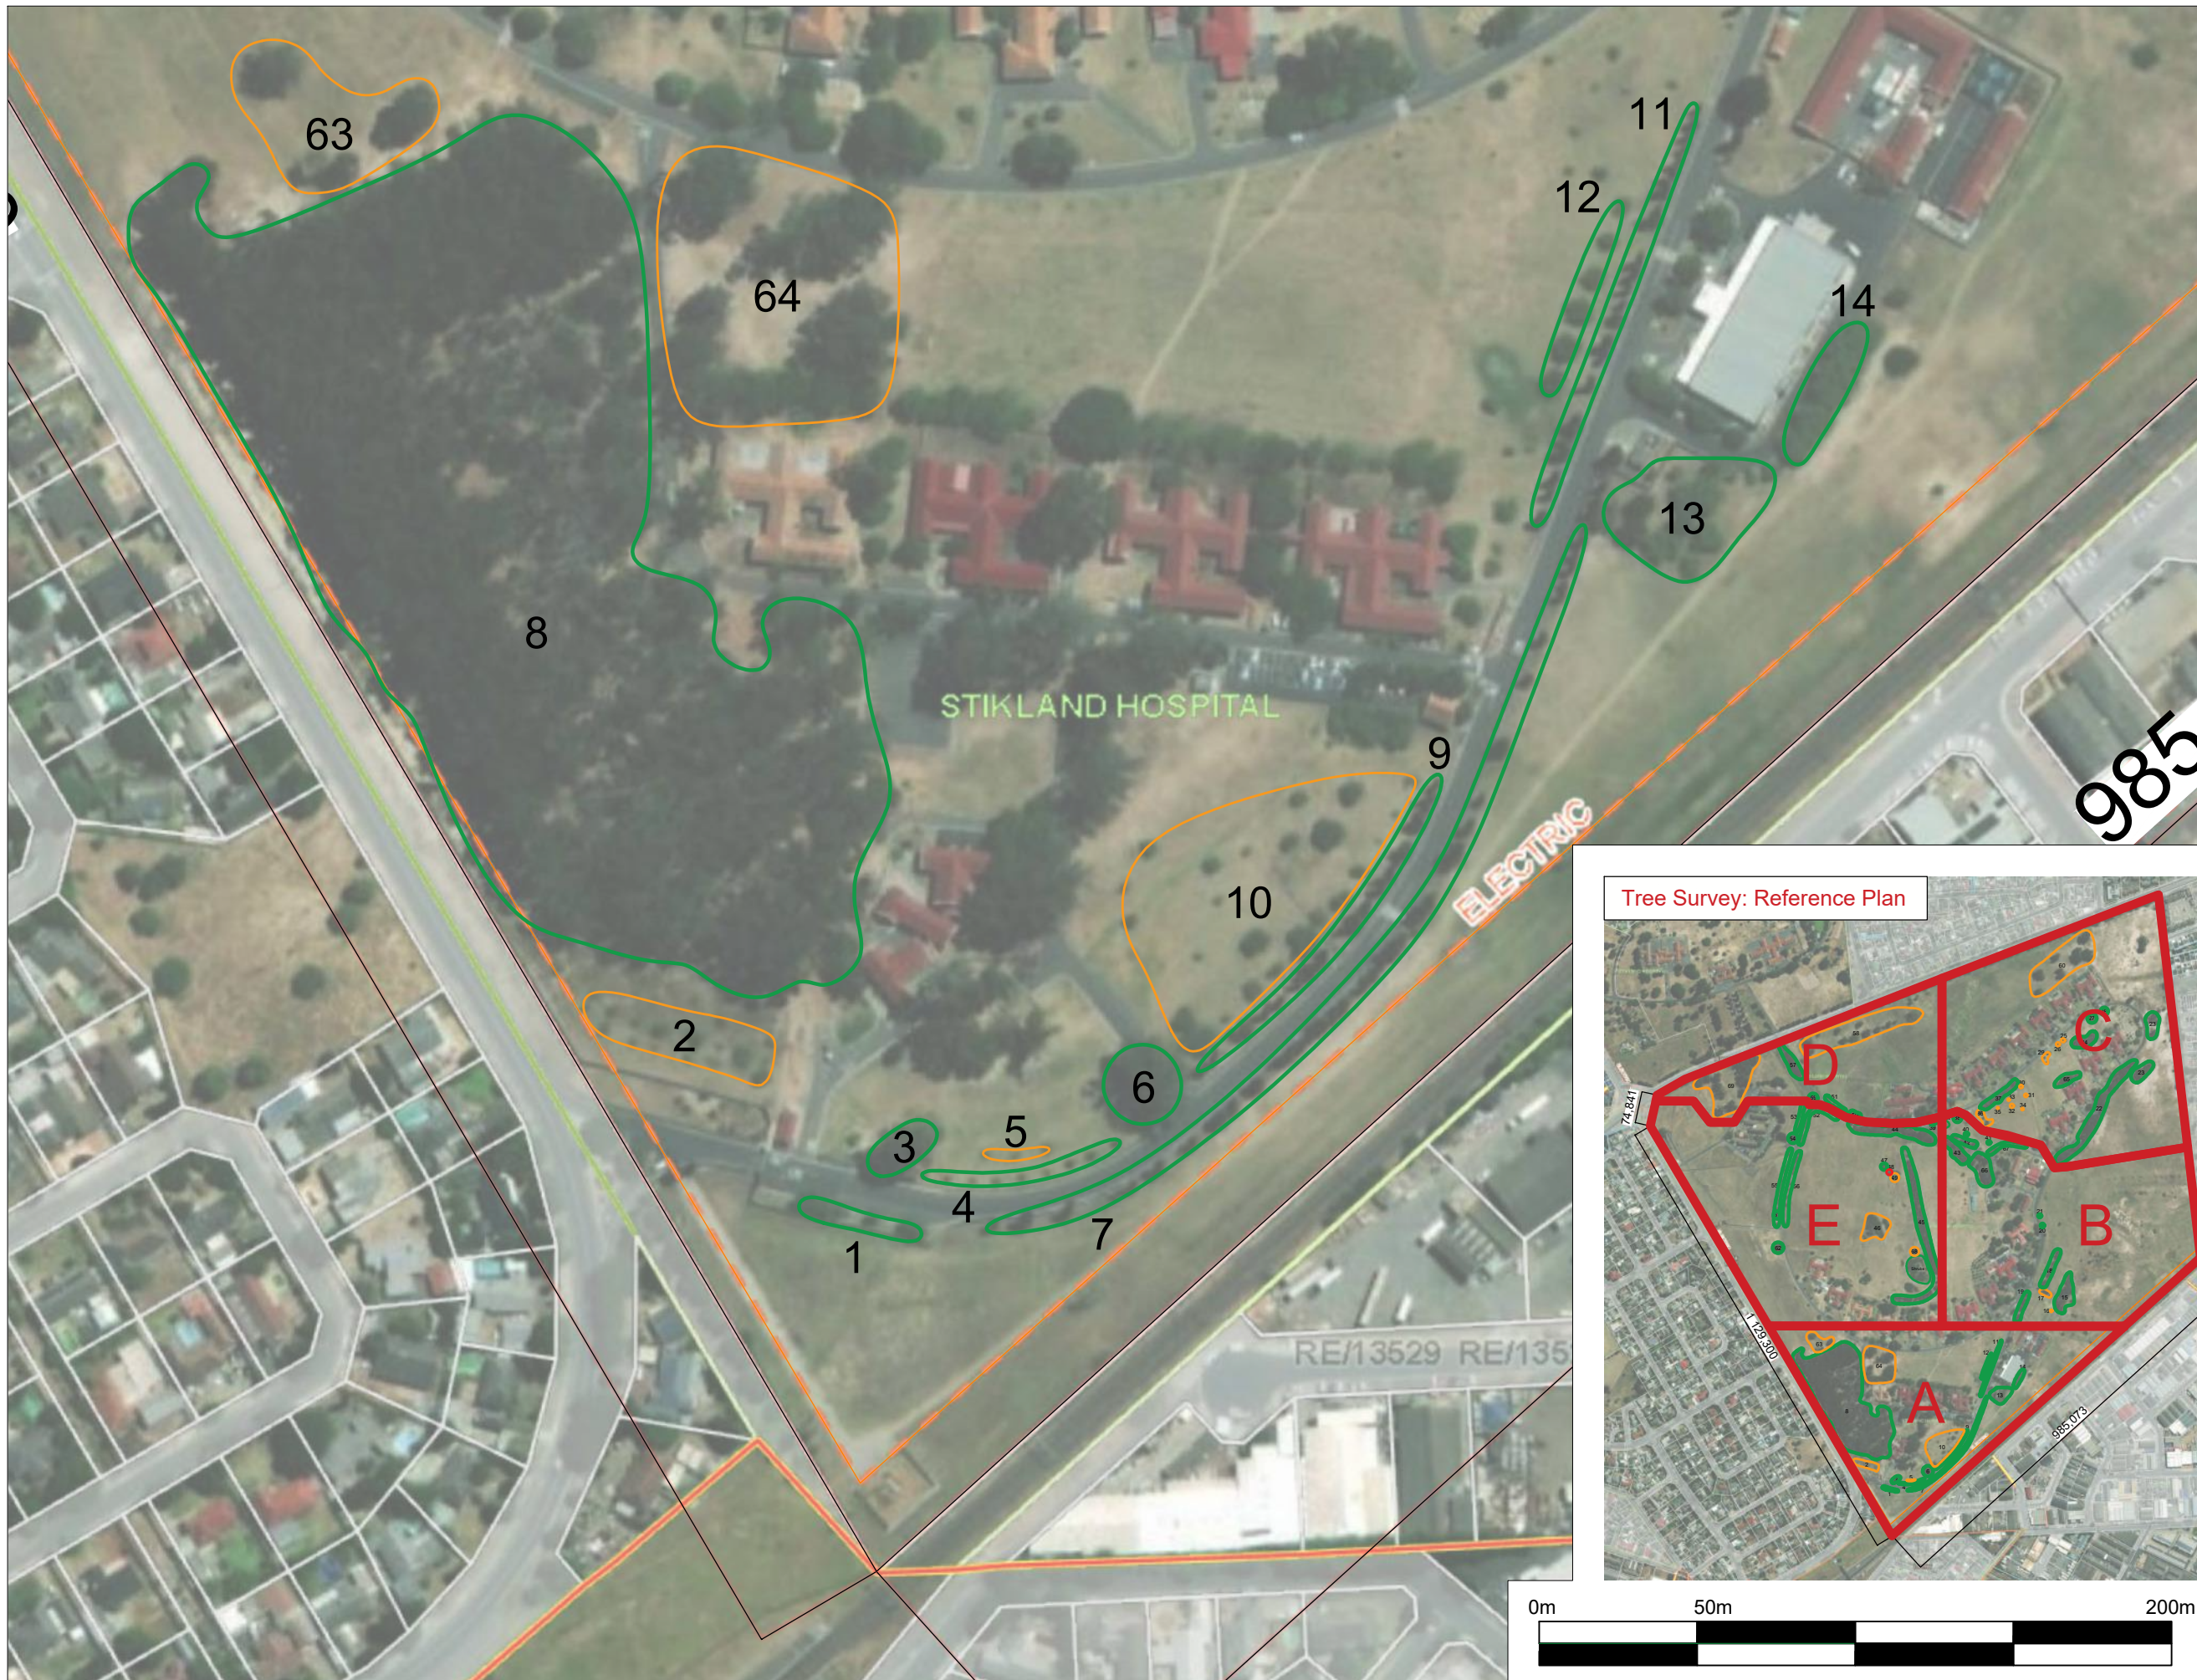
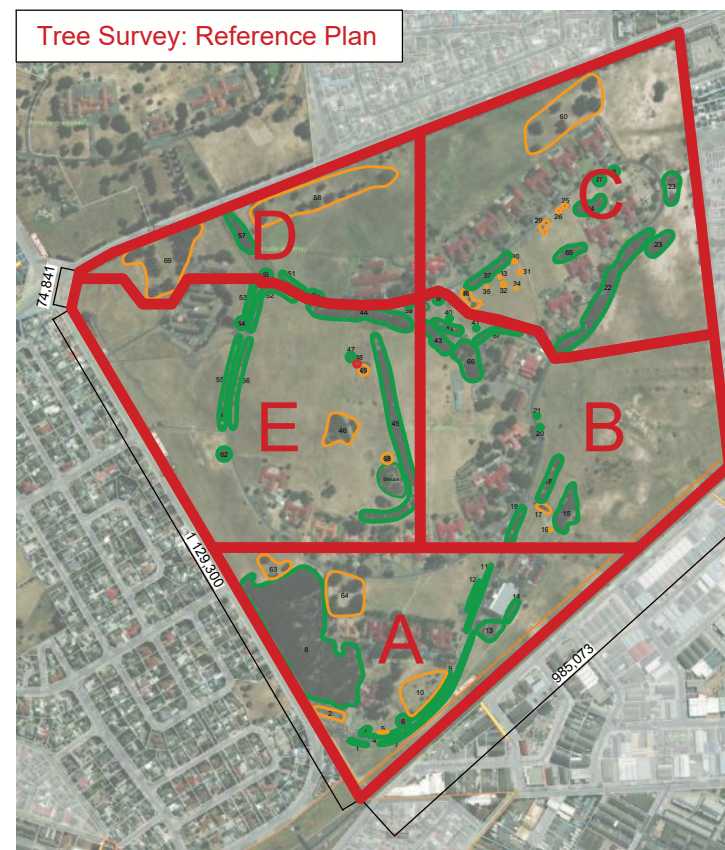
REVISION NOTES	DATE	REV
FOR APPROVAL	2023-06-29	0

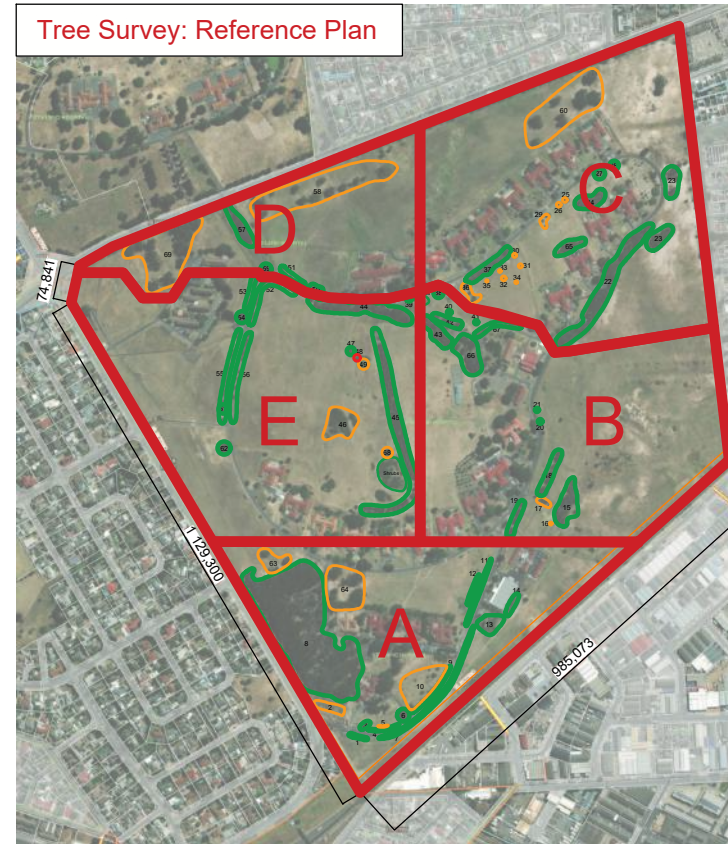
REVISION NOTES	DATE	BY
FOR APPROVAL	xxxx-xx-xx	0

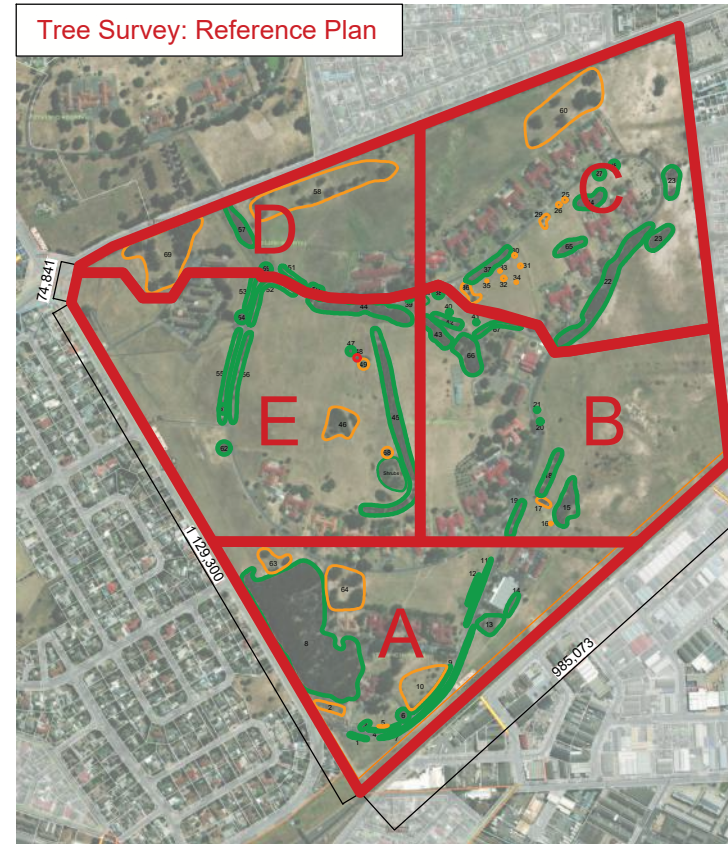
REVISION NOTES	DATE	REV
FOR APPROVAL	2023-06-29	0

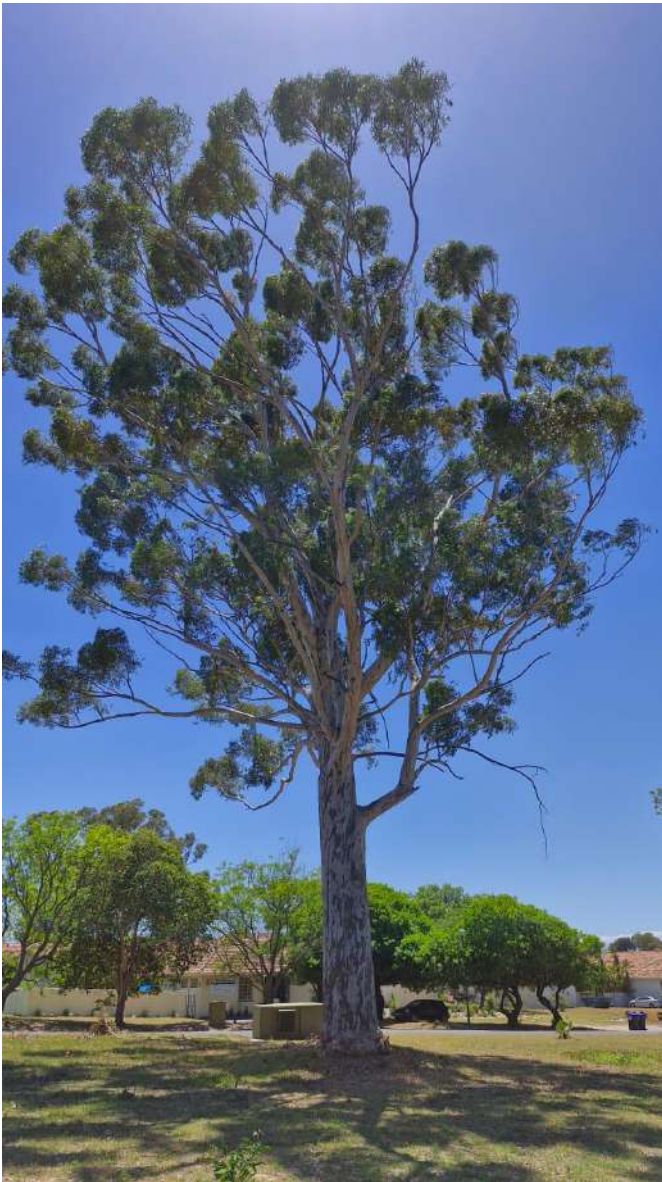
Figure 10: Free-standing Eucalyptus specimen located leeward of the forest. Original trunk formation. No coppiced regrowth. Magnificent specimen. Strongly recommended to be retained within the development footprint with development setbacks. Must be retained in combination with the woodlot portion of the forest for continued wind protection. Minimum development setback = canopy dripline plus 10m.

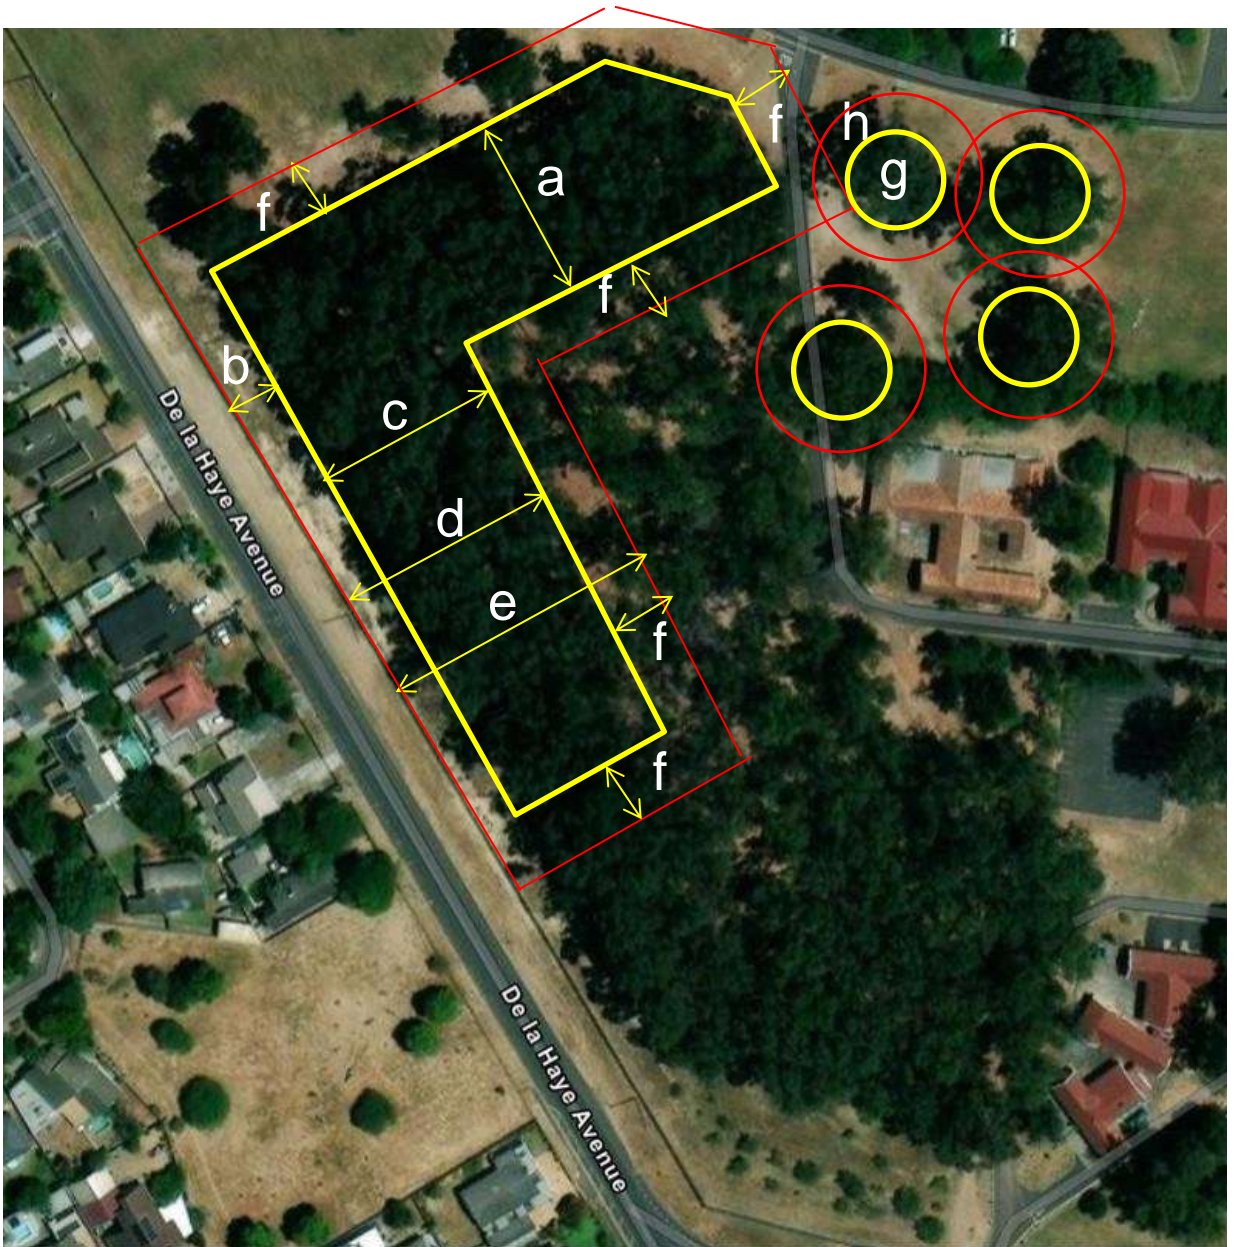
Figure 11: Recommended dimensions for the Eucalyptus forest and trees to be retained and development and management setback lines
